Fish Passage & Diversion Screening Inventory Database Report Cover Sheet

0.01 mi from beginning of SR 3 SB on-ramp to Finn Hill Rd, that is just beyond MP 52

Level A Culvert Assessment Report

Site ID:	996805		
Latitude:	47.7530926	Stream:	Johnson Cr
Longitude:	-122.6645702	Tributary To:	Liberty Bay
		WRIA:	15.0284
		Fish Use Potential:	Yes

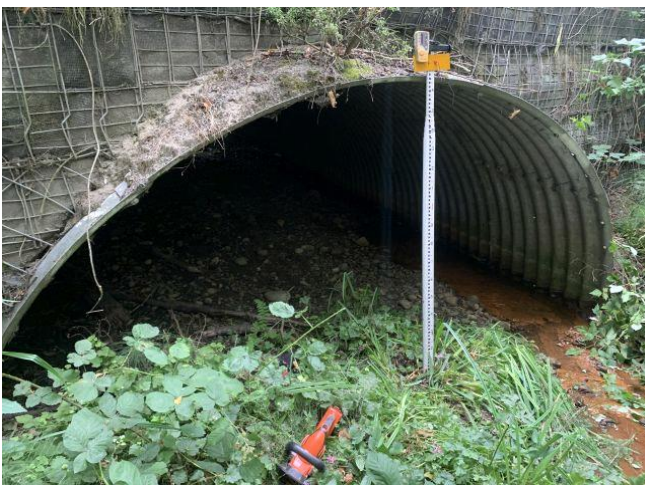
Culvert Details								Level A Parameters					
ID	Shape	Material	Span	Rise	Length	WDIC	Apron	WSDrop	Location	Countersunk	Backwater	Slope (%)	Sediment
1.1	ARCH	SPS	4.20	2.65	11.80	0.01	NO	0.00		Yes	No	-0.60	
All dimensions in meters

Channel Description	
Toe Width (m):	0.85
Average Width (m):	1.90
Culvert/Stream Width Ratio:	2.21
Plunge Pool	
Length (m):	0.00
Max Depth (m):	-99.99
OHW Width (m):	-999.99
Road	
Fill Depth (m):	8.00

Assessment Results		Tidal Influence:	No	Tidegate Present:	No
Barrier:	No	Passability (%):	100	Method:	Level A
Reason:	N/A	Fishway Present:	No	Recheck:

Comments
Reinforced sheer vertical wall with fencing both US and DS.
